NATIONAL PHOTOGRAPHIC INTERPRETATION CENTER

HIGHWAY BRIDGES, ROUTE 7 BAN KEN AREA, LAOS

NPIC J.7291 (1/65)

CSD/NPIC 9/65
22 JANUARY 1965
PAGE 2HSA
WB
RSHIGHWAY BRIDGES, ROUTE 7
BAN KEN AREA, LAOS

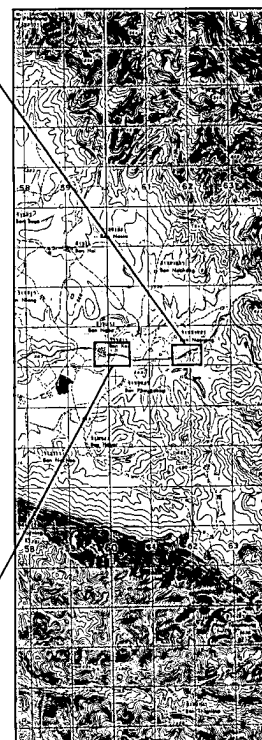
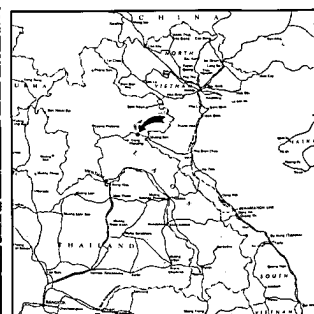
b) [REDACTED] REVEALED A HIGHWAY BRIDGE OVER THE NAM MAT (RIVER) ON ROUTE 7, JUST EAST OF BAN KEN. THE BRIDGE WAS A THREE SPAN, HALF-THROUGH TRUSS, PROBABLE STEEL WITH WOODEN PLANKING.

c) POST-STRIKE PHOTOGRAPHY OF [REDACTED] [REDACTED] [REDACTED] REVEALED THE BRIDGE OVER THE NAM MAT (RIVER) DESTROYED WITH ONLY THE PIERS REMAINING. THE SPANS WERE OBSERVED LYING IN THE RIVER BED. NUMEROUS BOMB CRATERS WERE OBSERVED JUST WEST OF THE DESTROYED BRIDGE INTER-DICTING ROUTE 7. THE RIVER APPEARED FORDABLE.

REVEALS A BY-PASS ROAD LEADING FROM ROUTE 7 TO A
VEHICLE FORD JUST NORTH OF THE DESTROYED BRIDGE.
A FOOT FORD IS ALSO OBSERVED ACROSS THE RIVER.

[] REVEALED A HIGHWAY BRIDGE OVER THE
NAM TIEN (RIVER) ON ROUTE 7, 0.4 NM SOUTH-SOUTHEAST
OF BAN NHONG AND 1.0 NM EAST OF BAN KEN. THE
BRIDGE WAS A THREE SPAN, HALF-THROUGH TRUSS PROBABLE
STEEL WITH WOODEN PLANKING.

[] REVEALED A CLOUD OF SMOKE RISING FROM
THE AREA OF THE BRIDGE. THE HEAVY SMOKE PREVENTED A
DAMAGE ASSESSMENT. THE RIVER WAS OBSERVED TO BE
FORDABLE AT A NUMBER OF LOCATIONS.

REVEALS THE EASTERN SPAN OF THE BRIDGE OVER THE NAM
TIEN (RIVER) PARTIALLY DAMAGED. THE BRIDGE IS SERVICE-
ABLE FOR FOOT TRAFFIC. A FORD JUST SOUTH OF THE DAMAGED
BRIDGE MAKES ROUTE 7 PASSABLE TO VEHICULAR TRAFFIC.
